Design and Construction of Creekside Town Center Bridges

Peter A. Giessel, P.E.
Reid Middleton, Inc.

Creekside Town Center Bridges

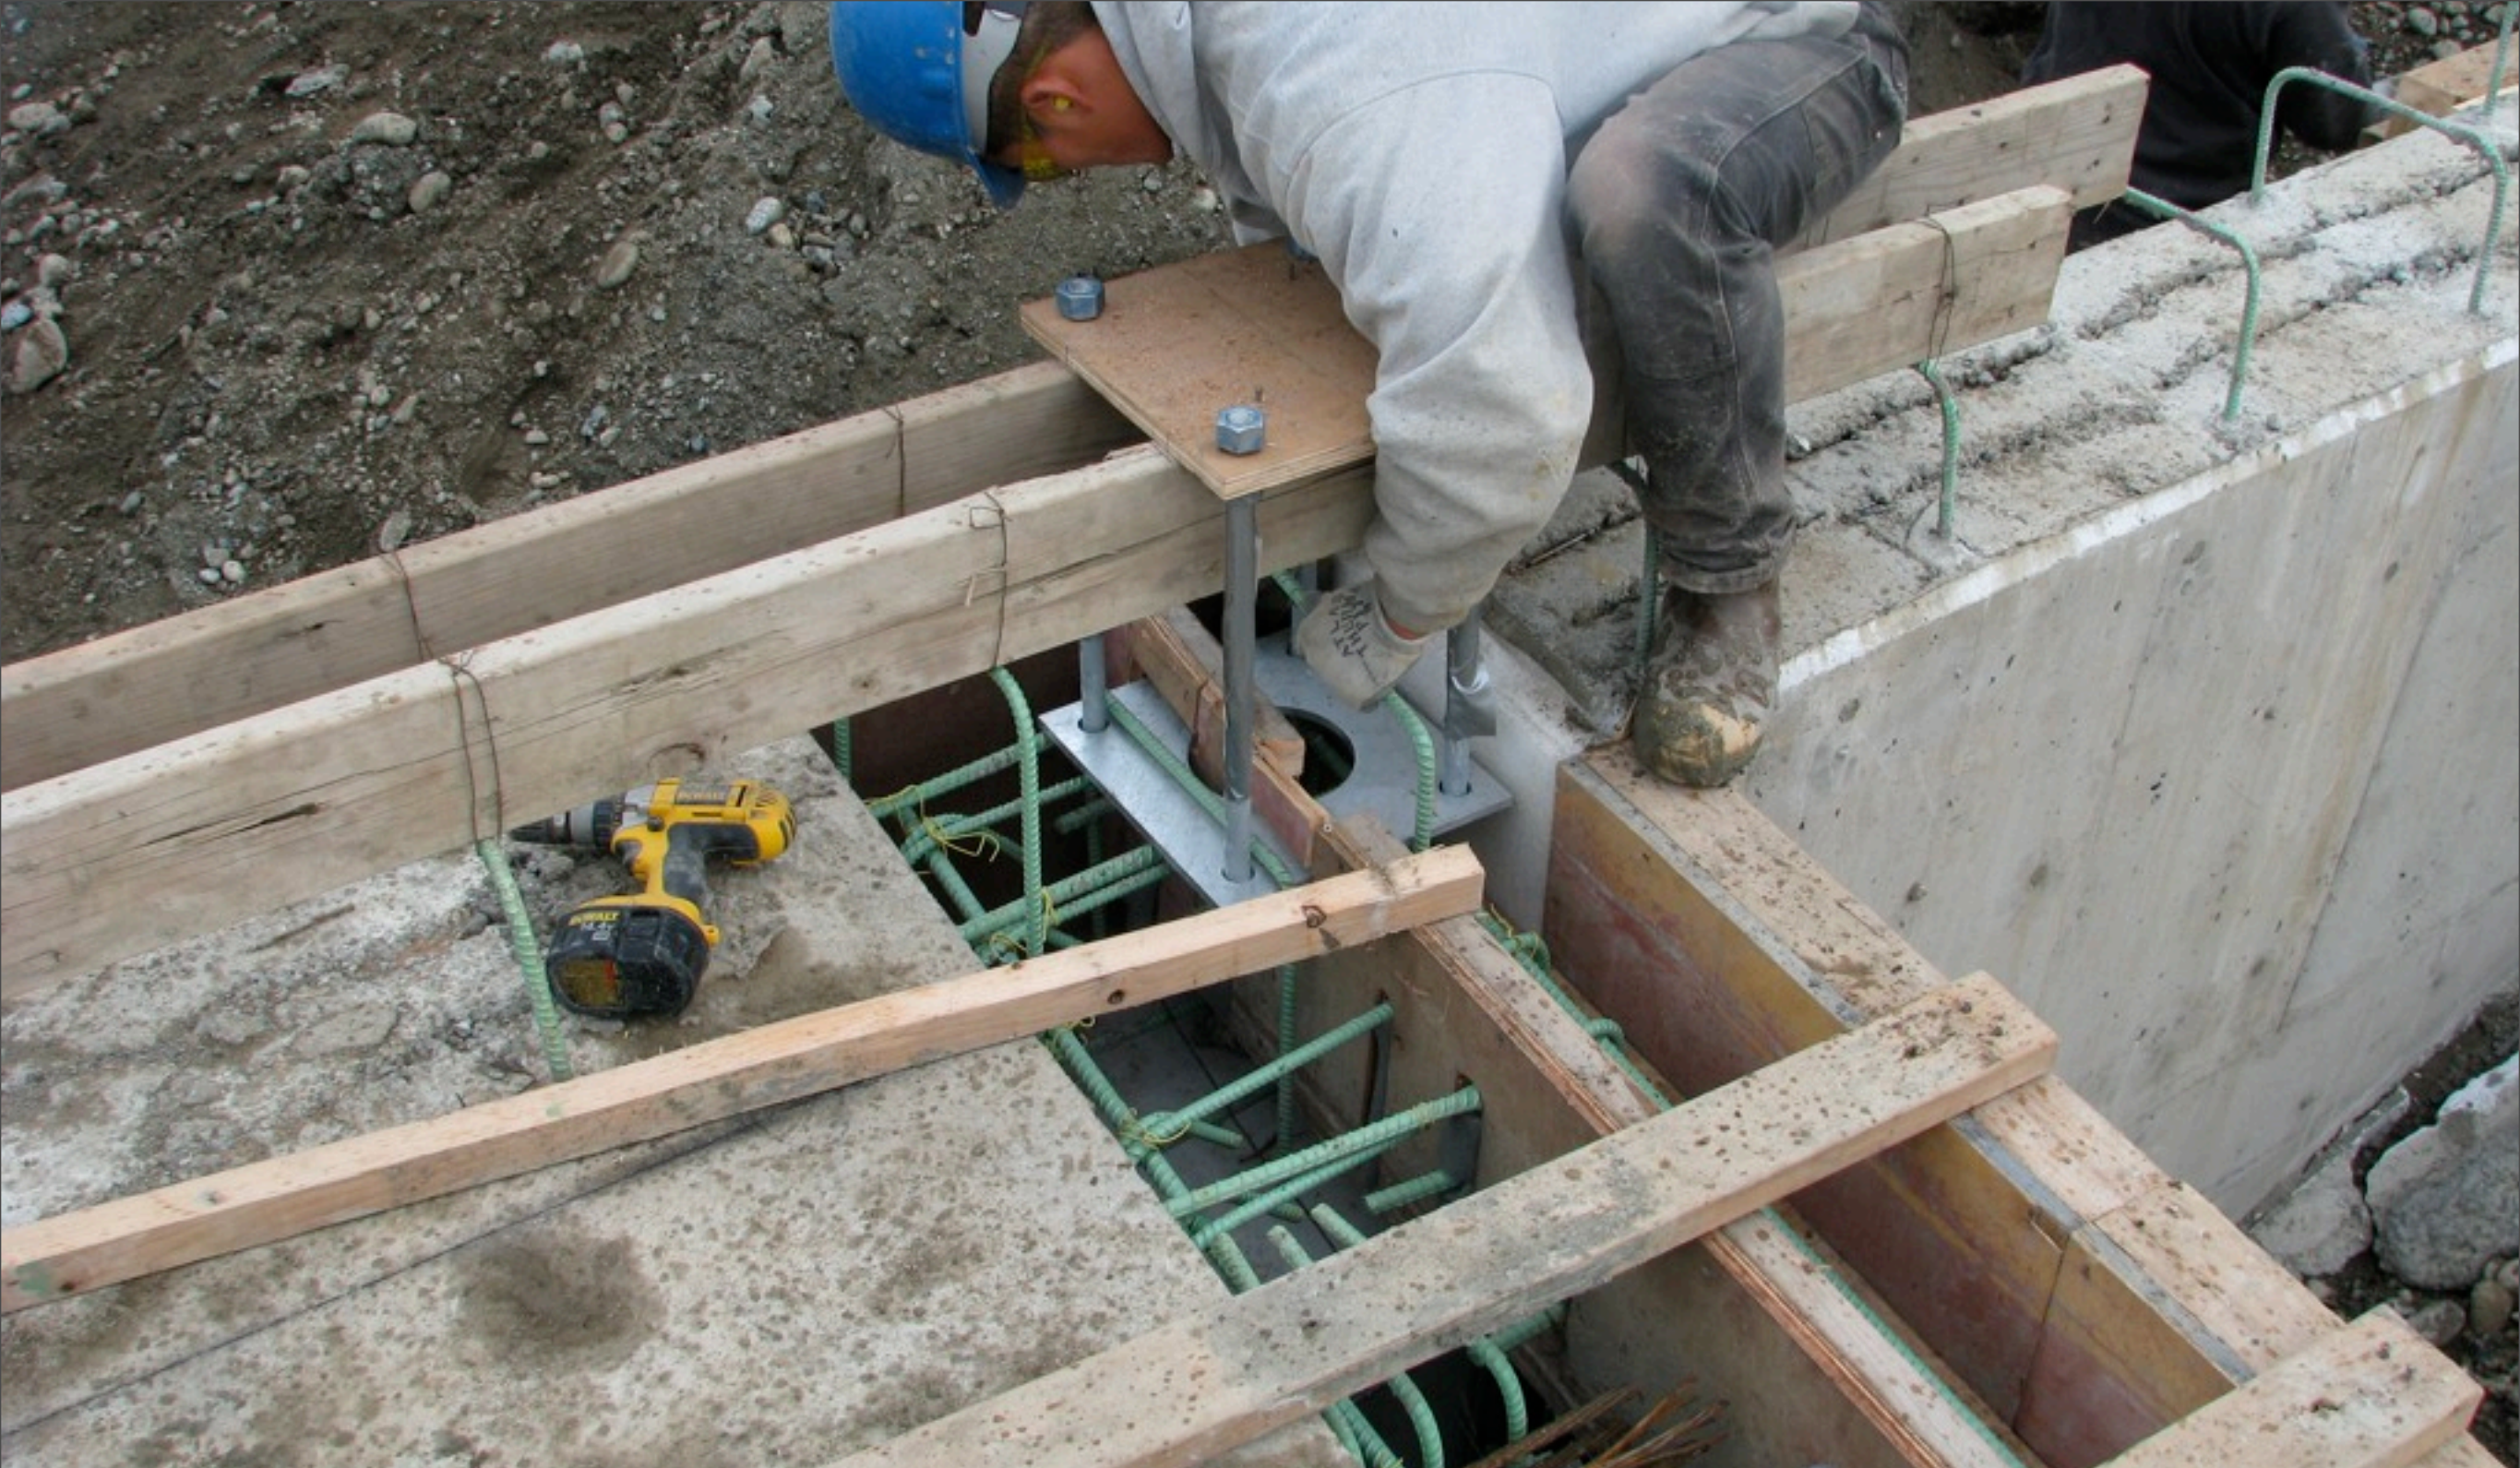
Installing Forgotten Railing Base Plates

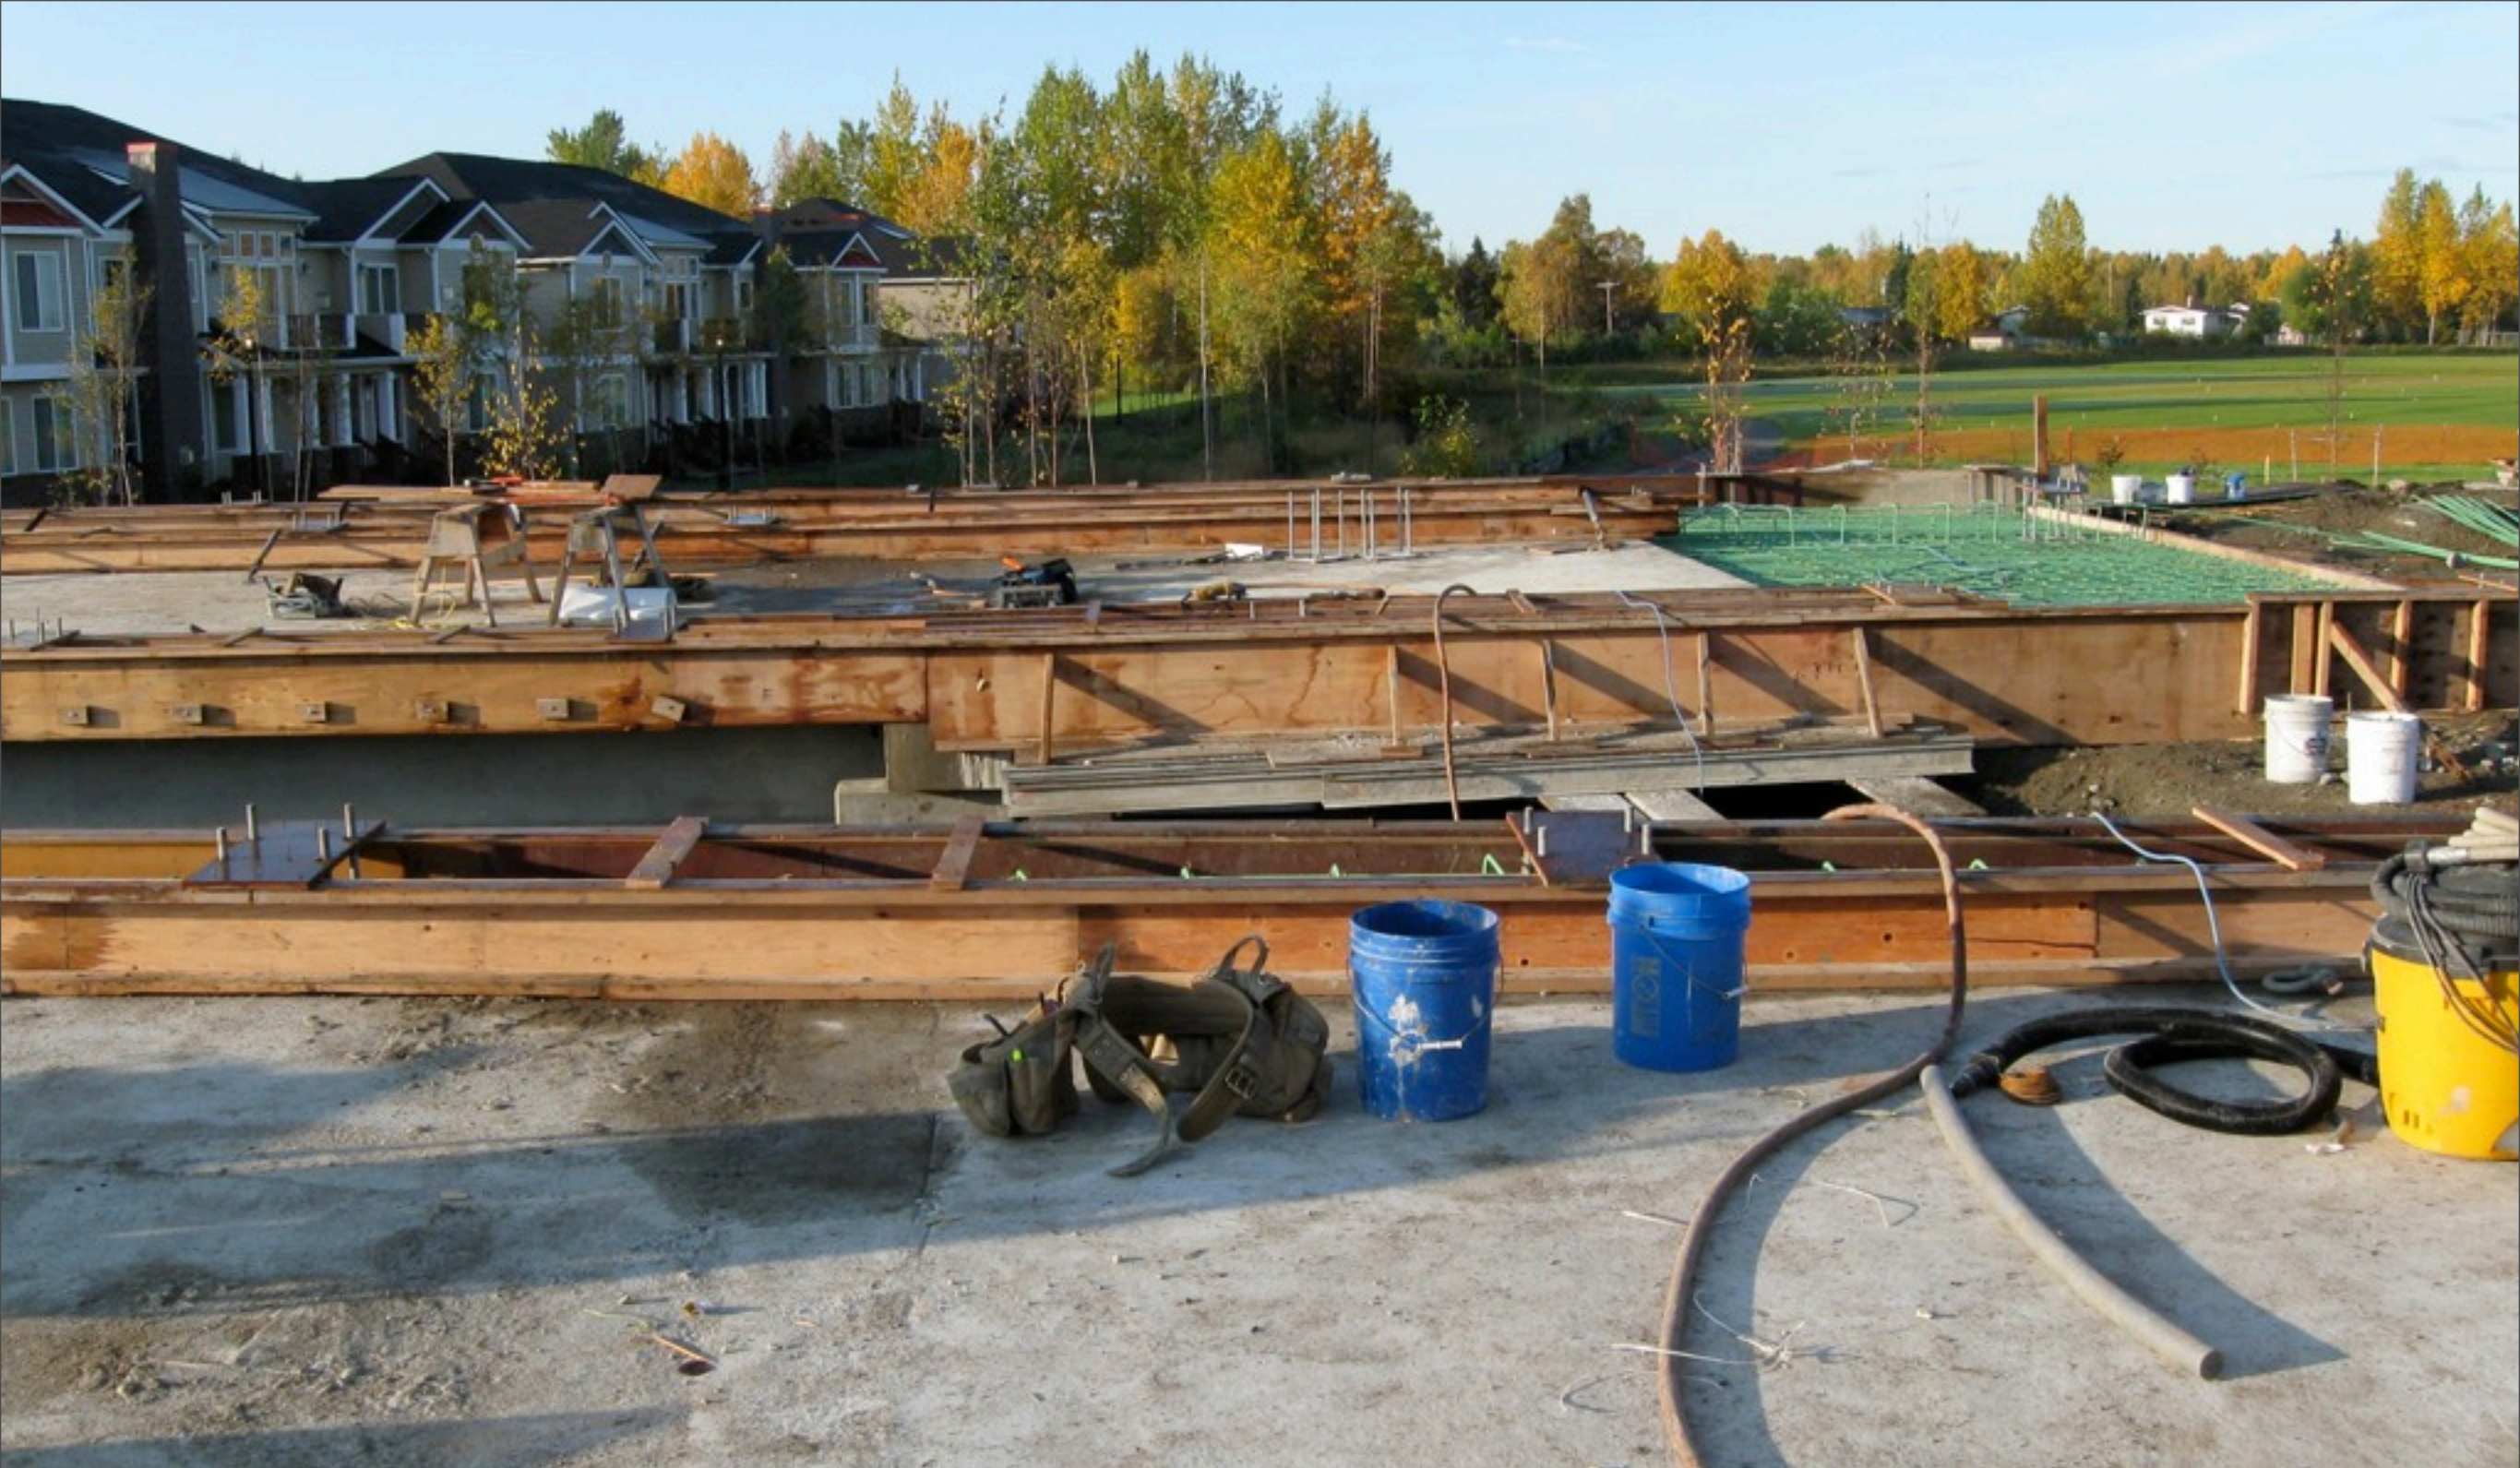
Span 1 Slope Issue

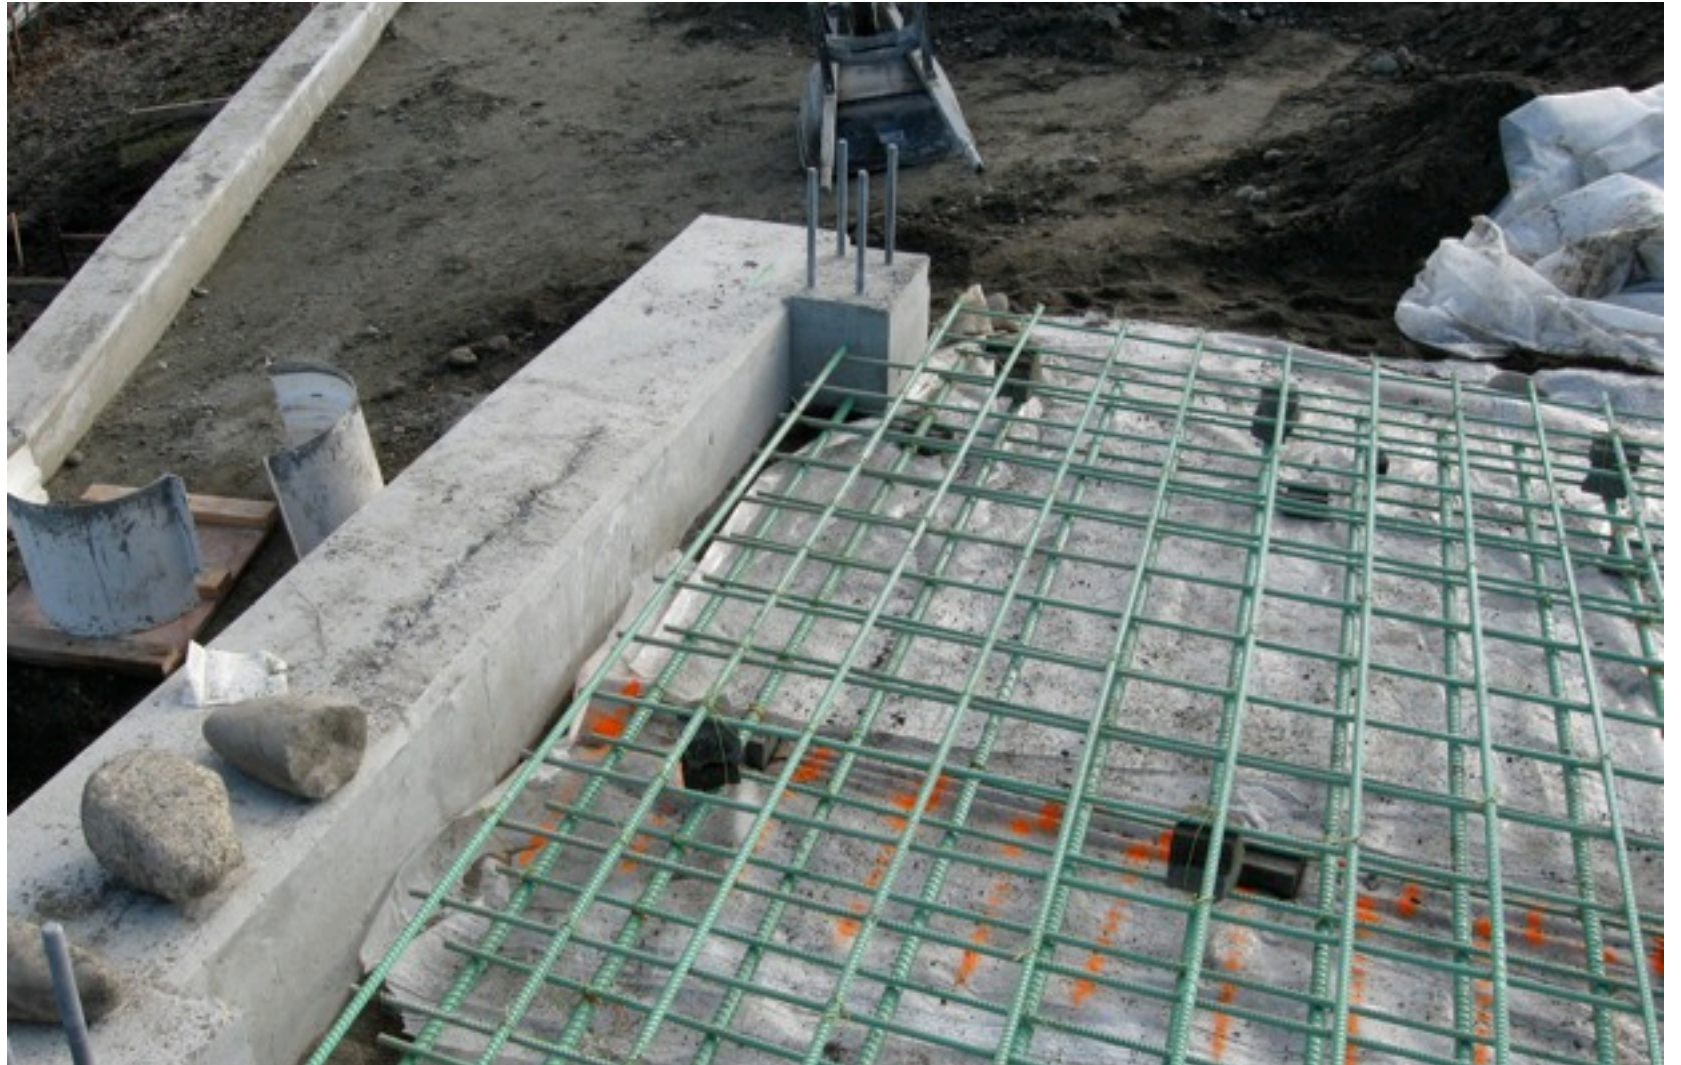
South Approach Slab Railing Issue / Light Post attached to MSE Wall
September 27, 2008

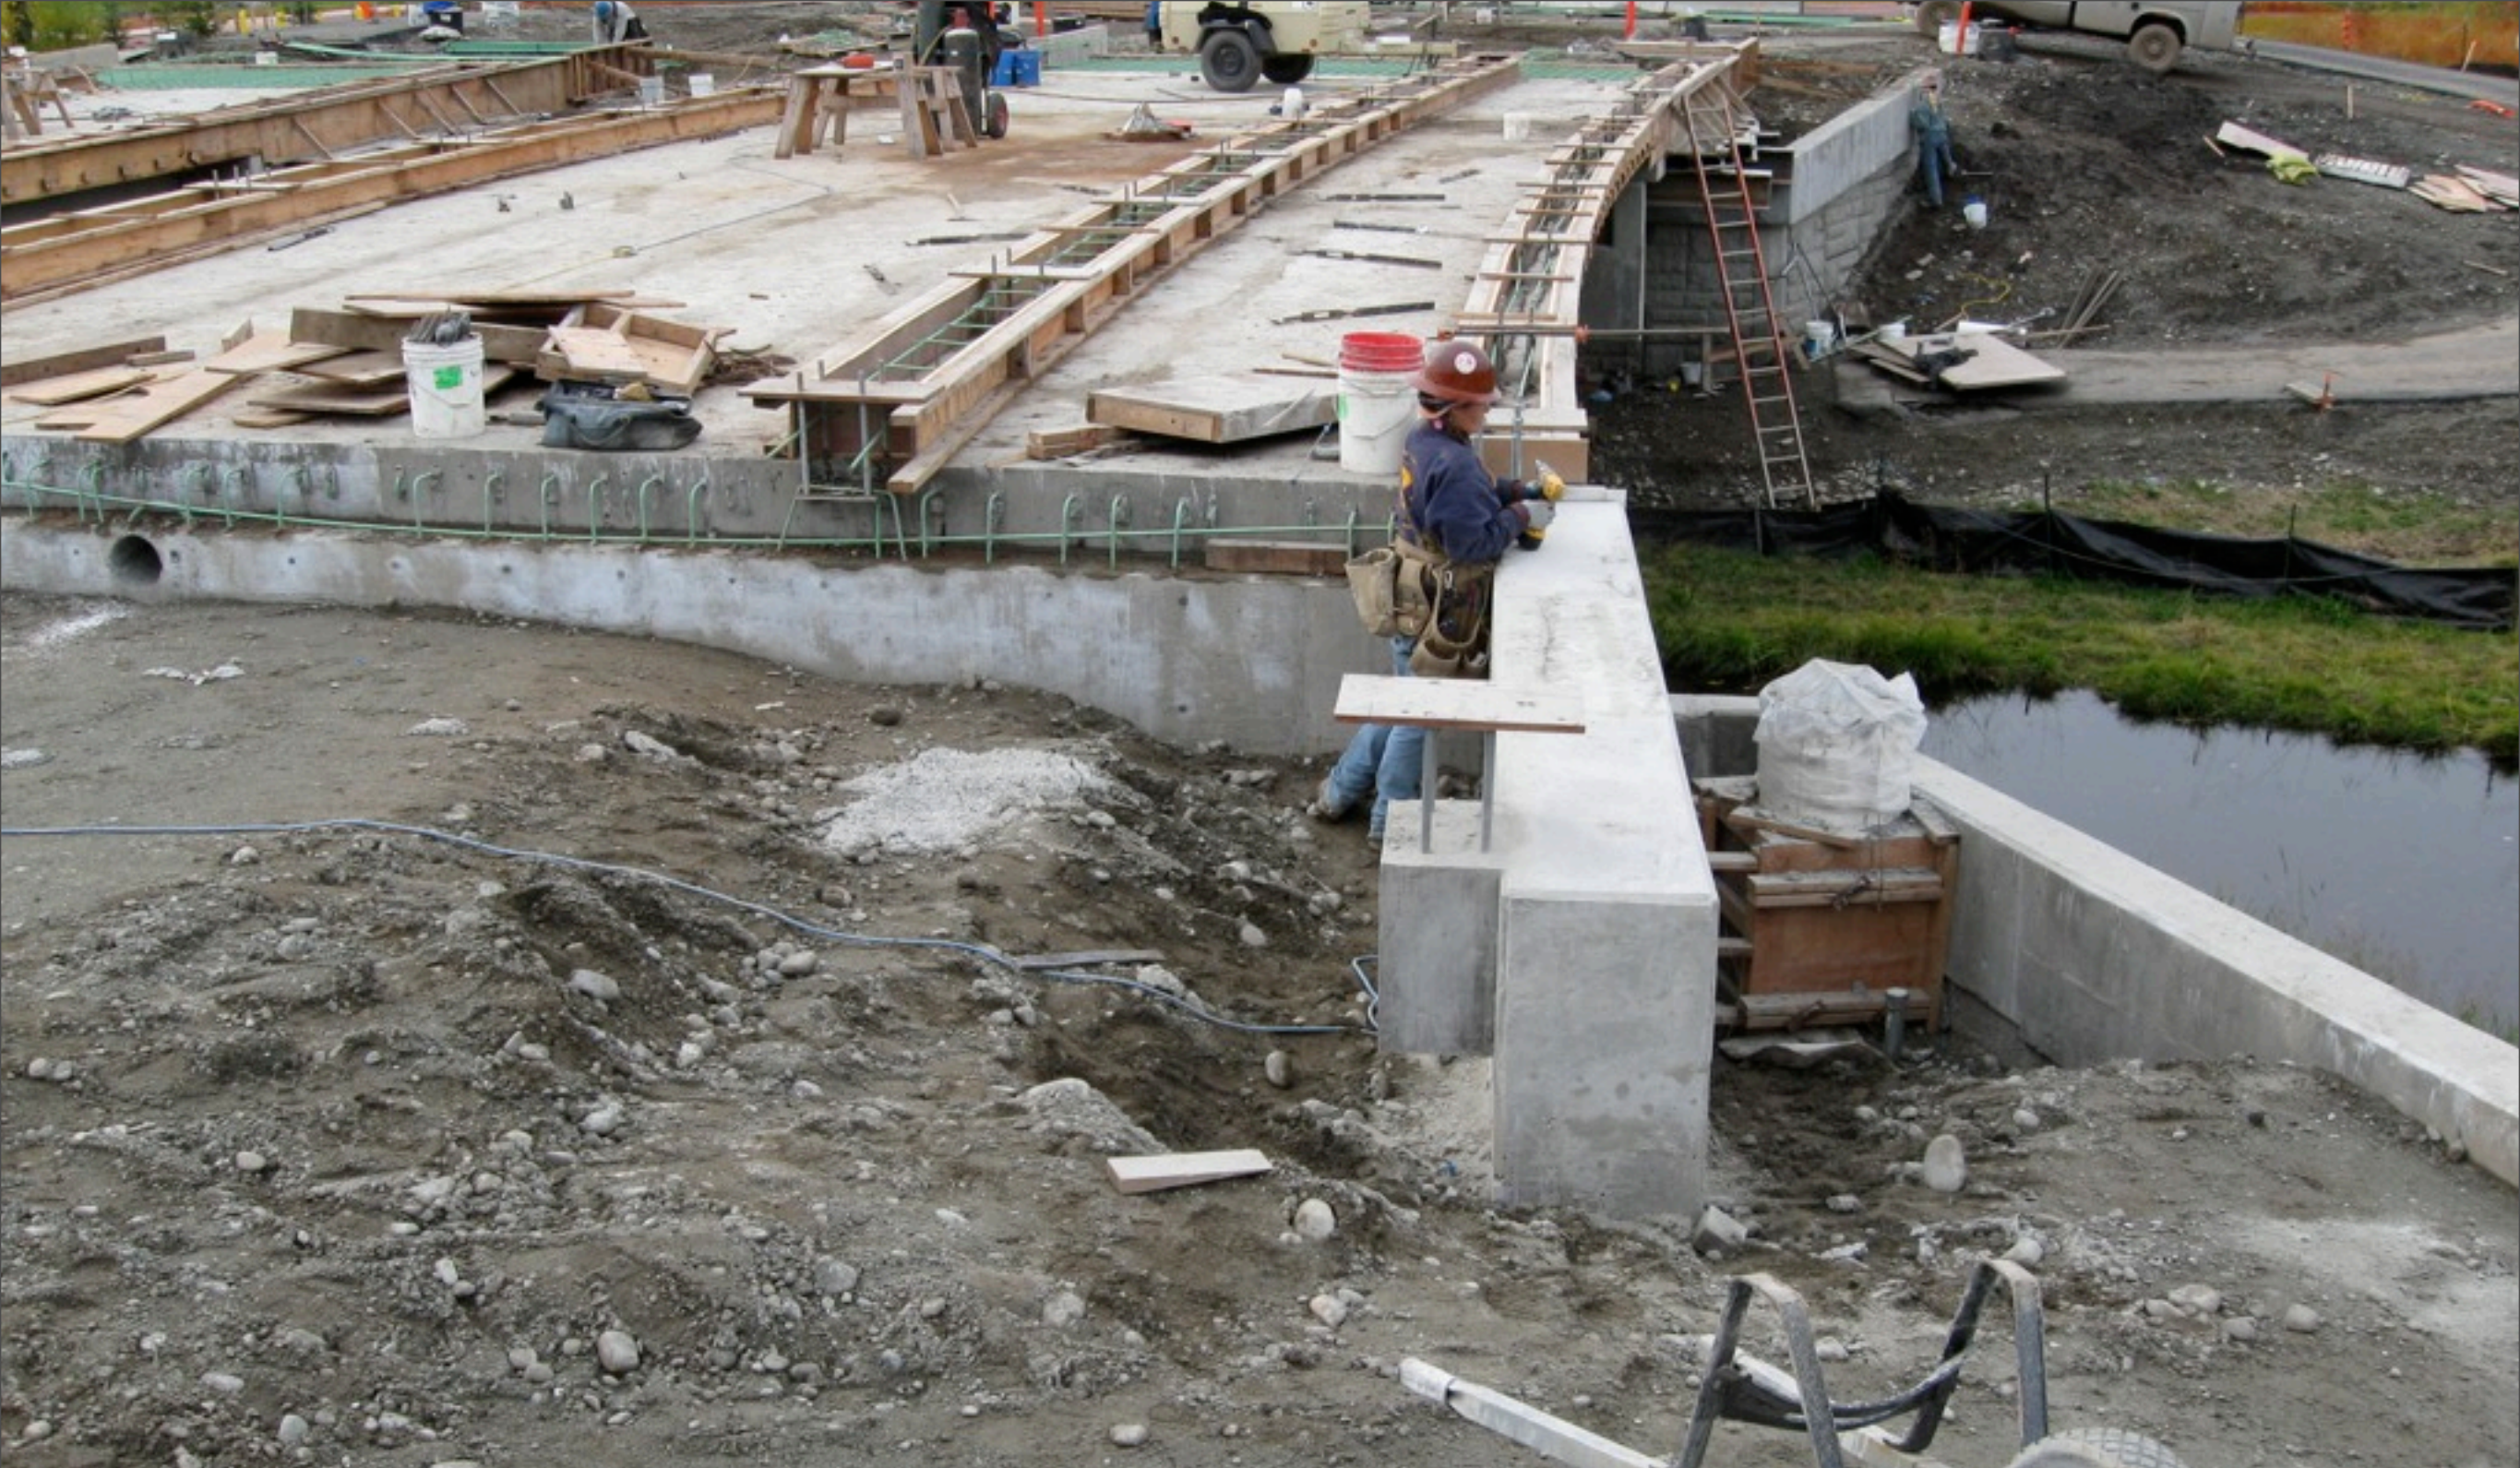
Eastmost Girder Pedestrian Railing Issue

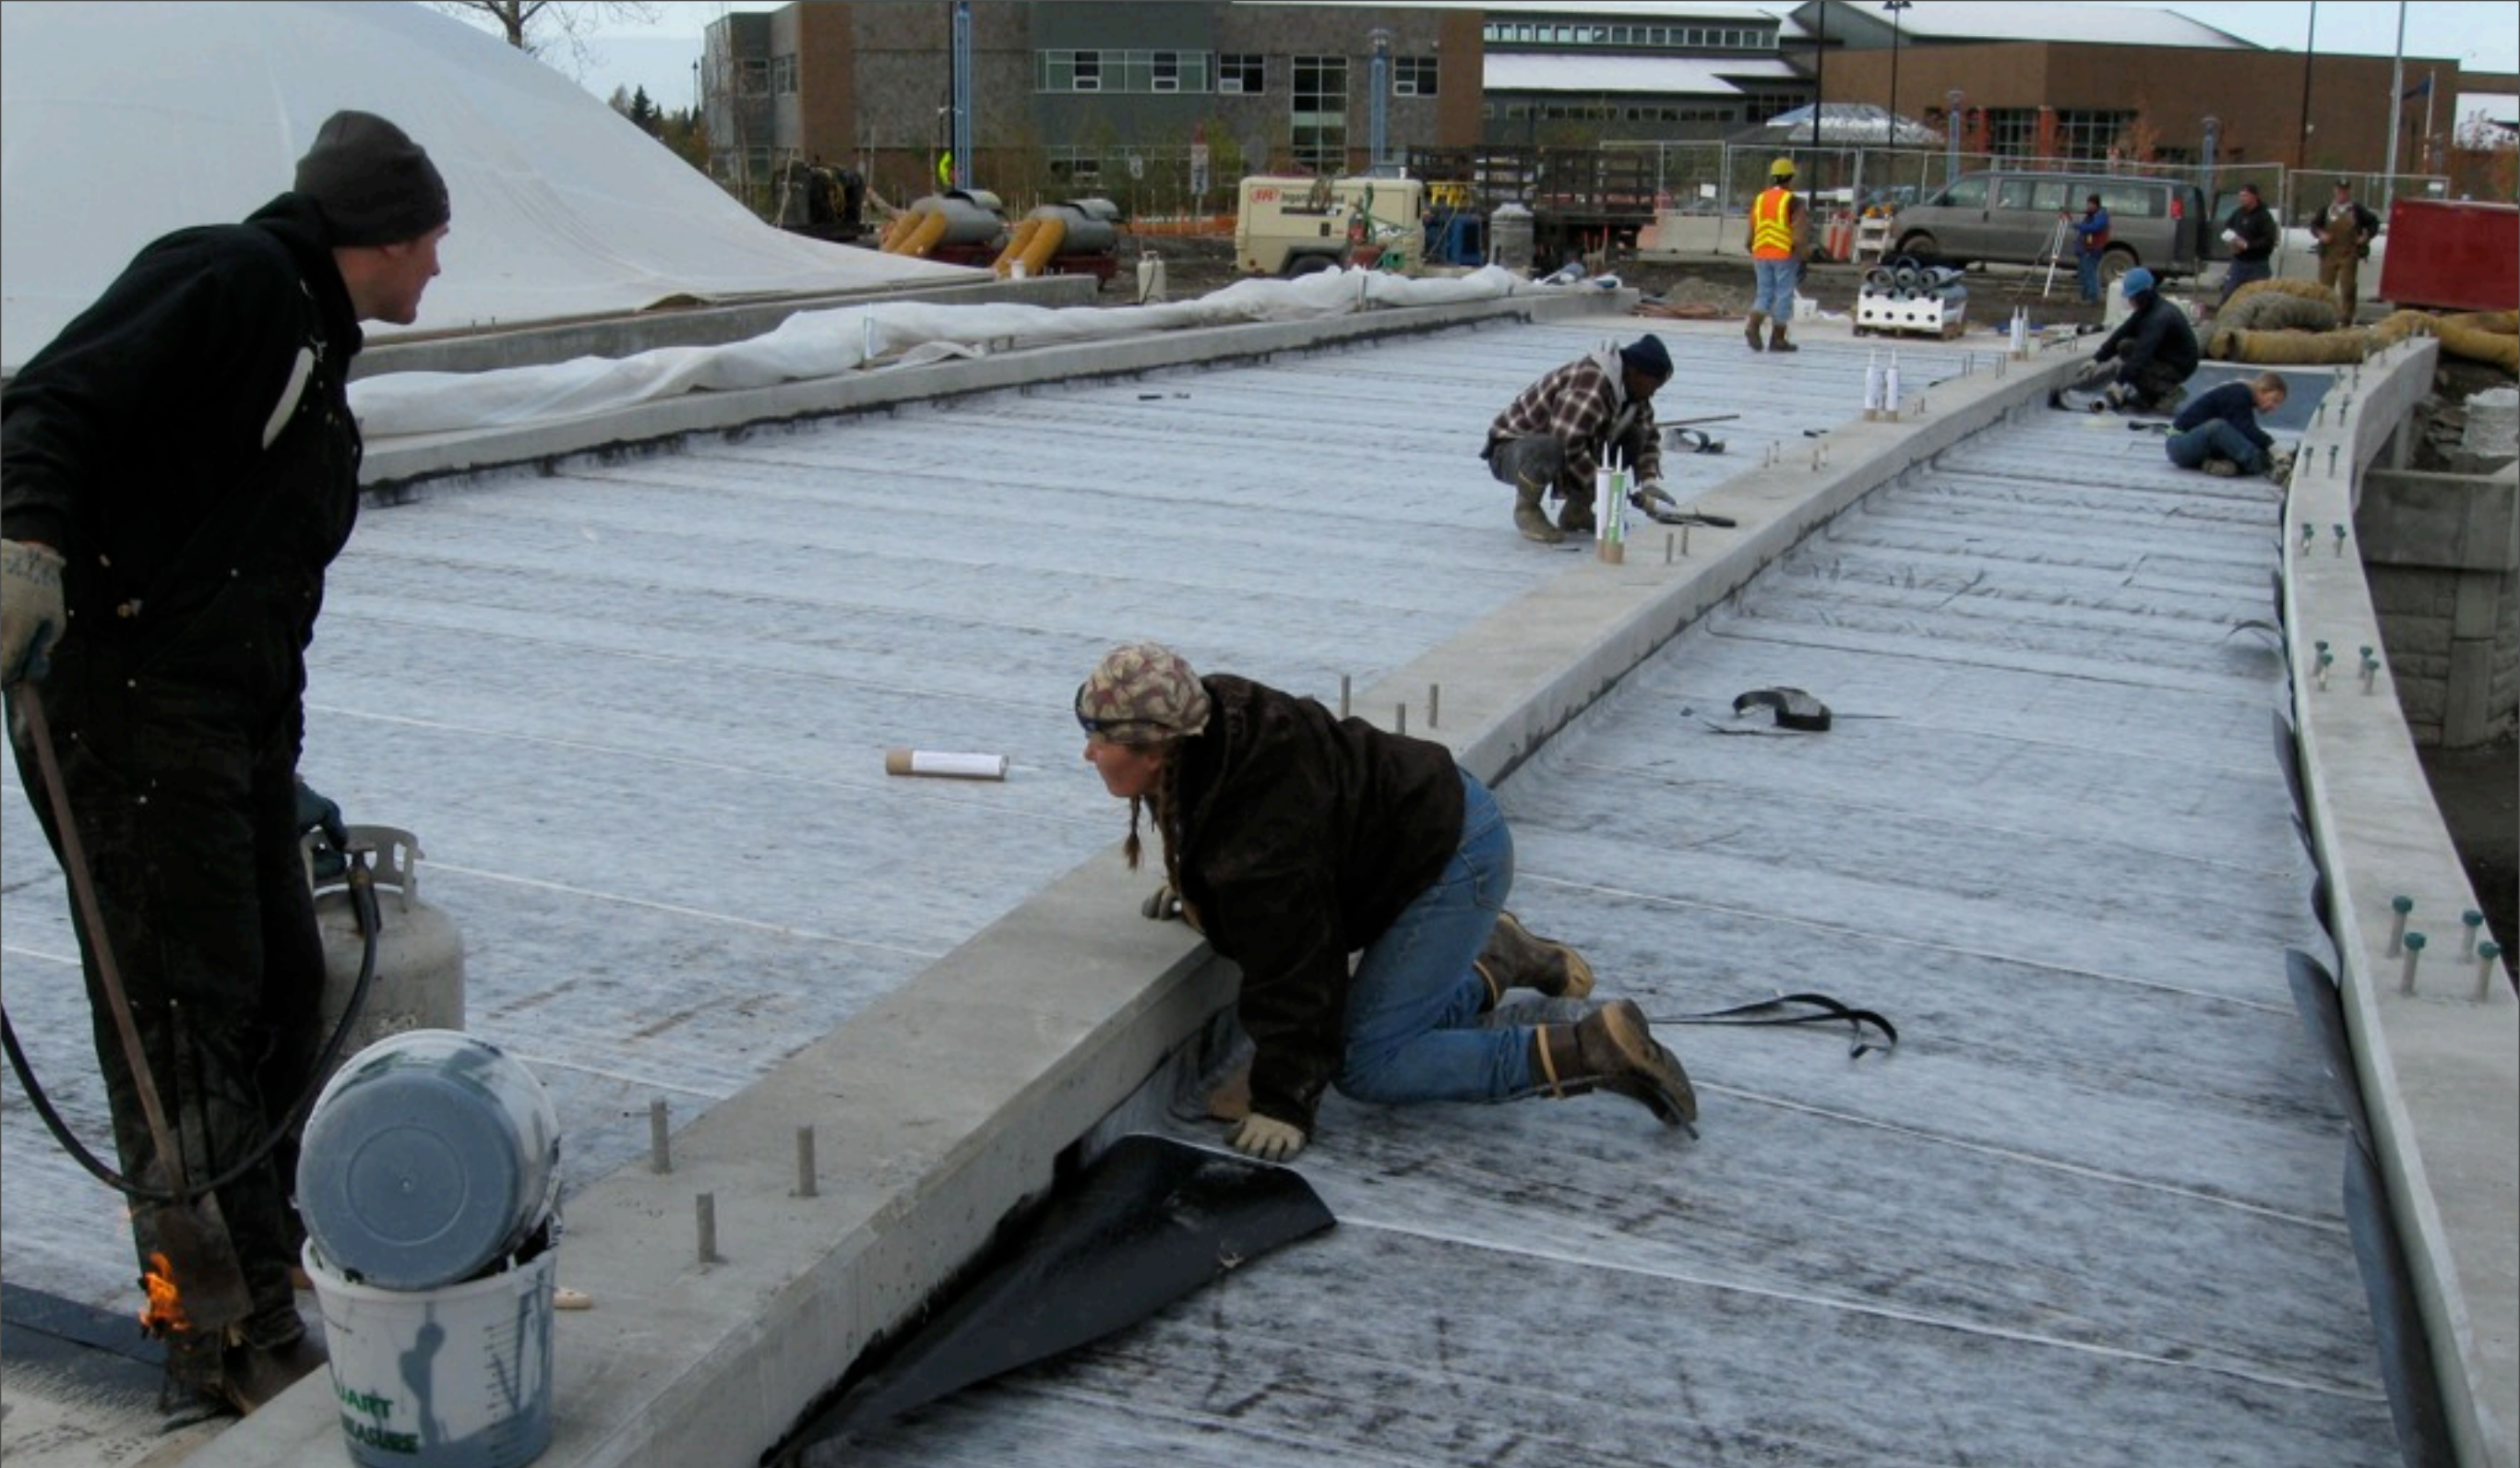
Installing Waterproof Membrane

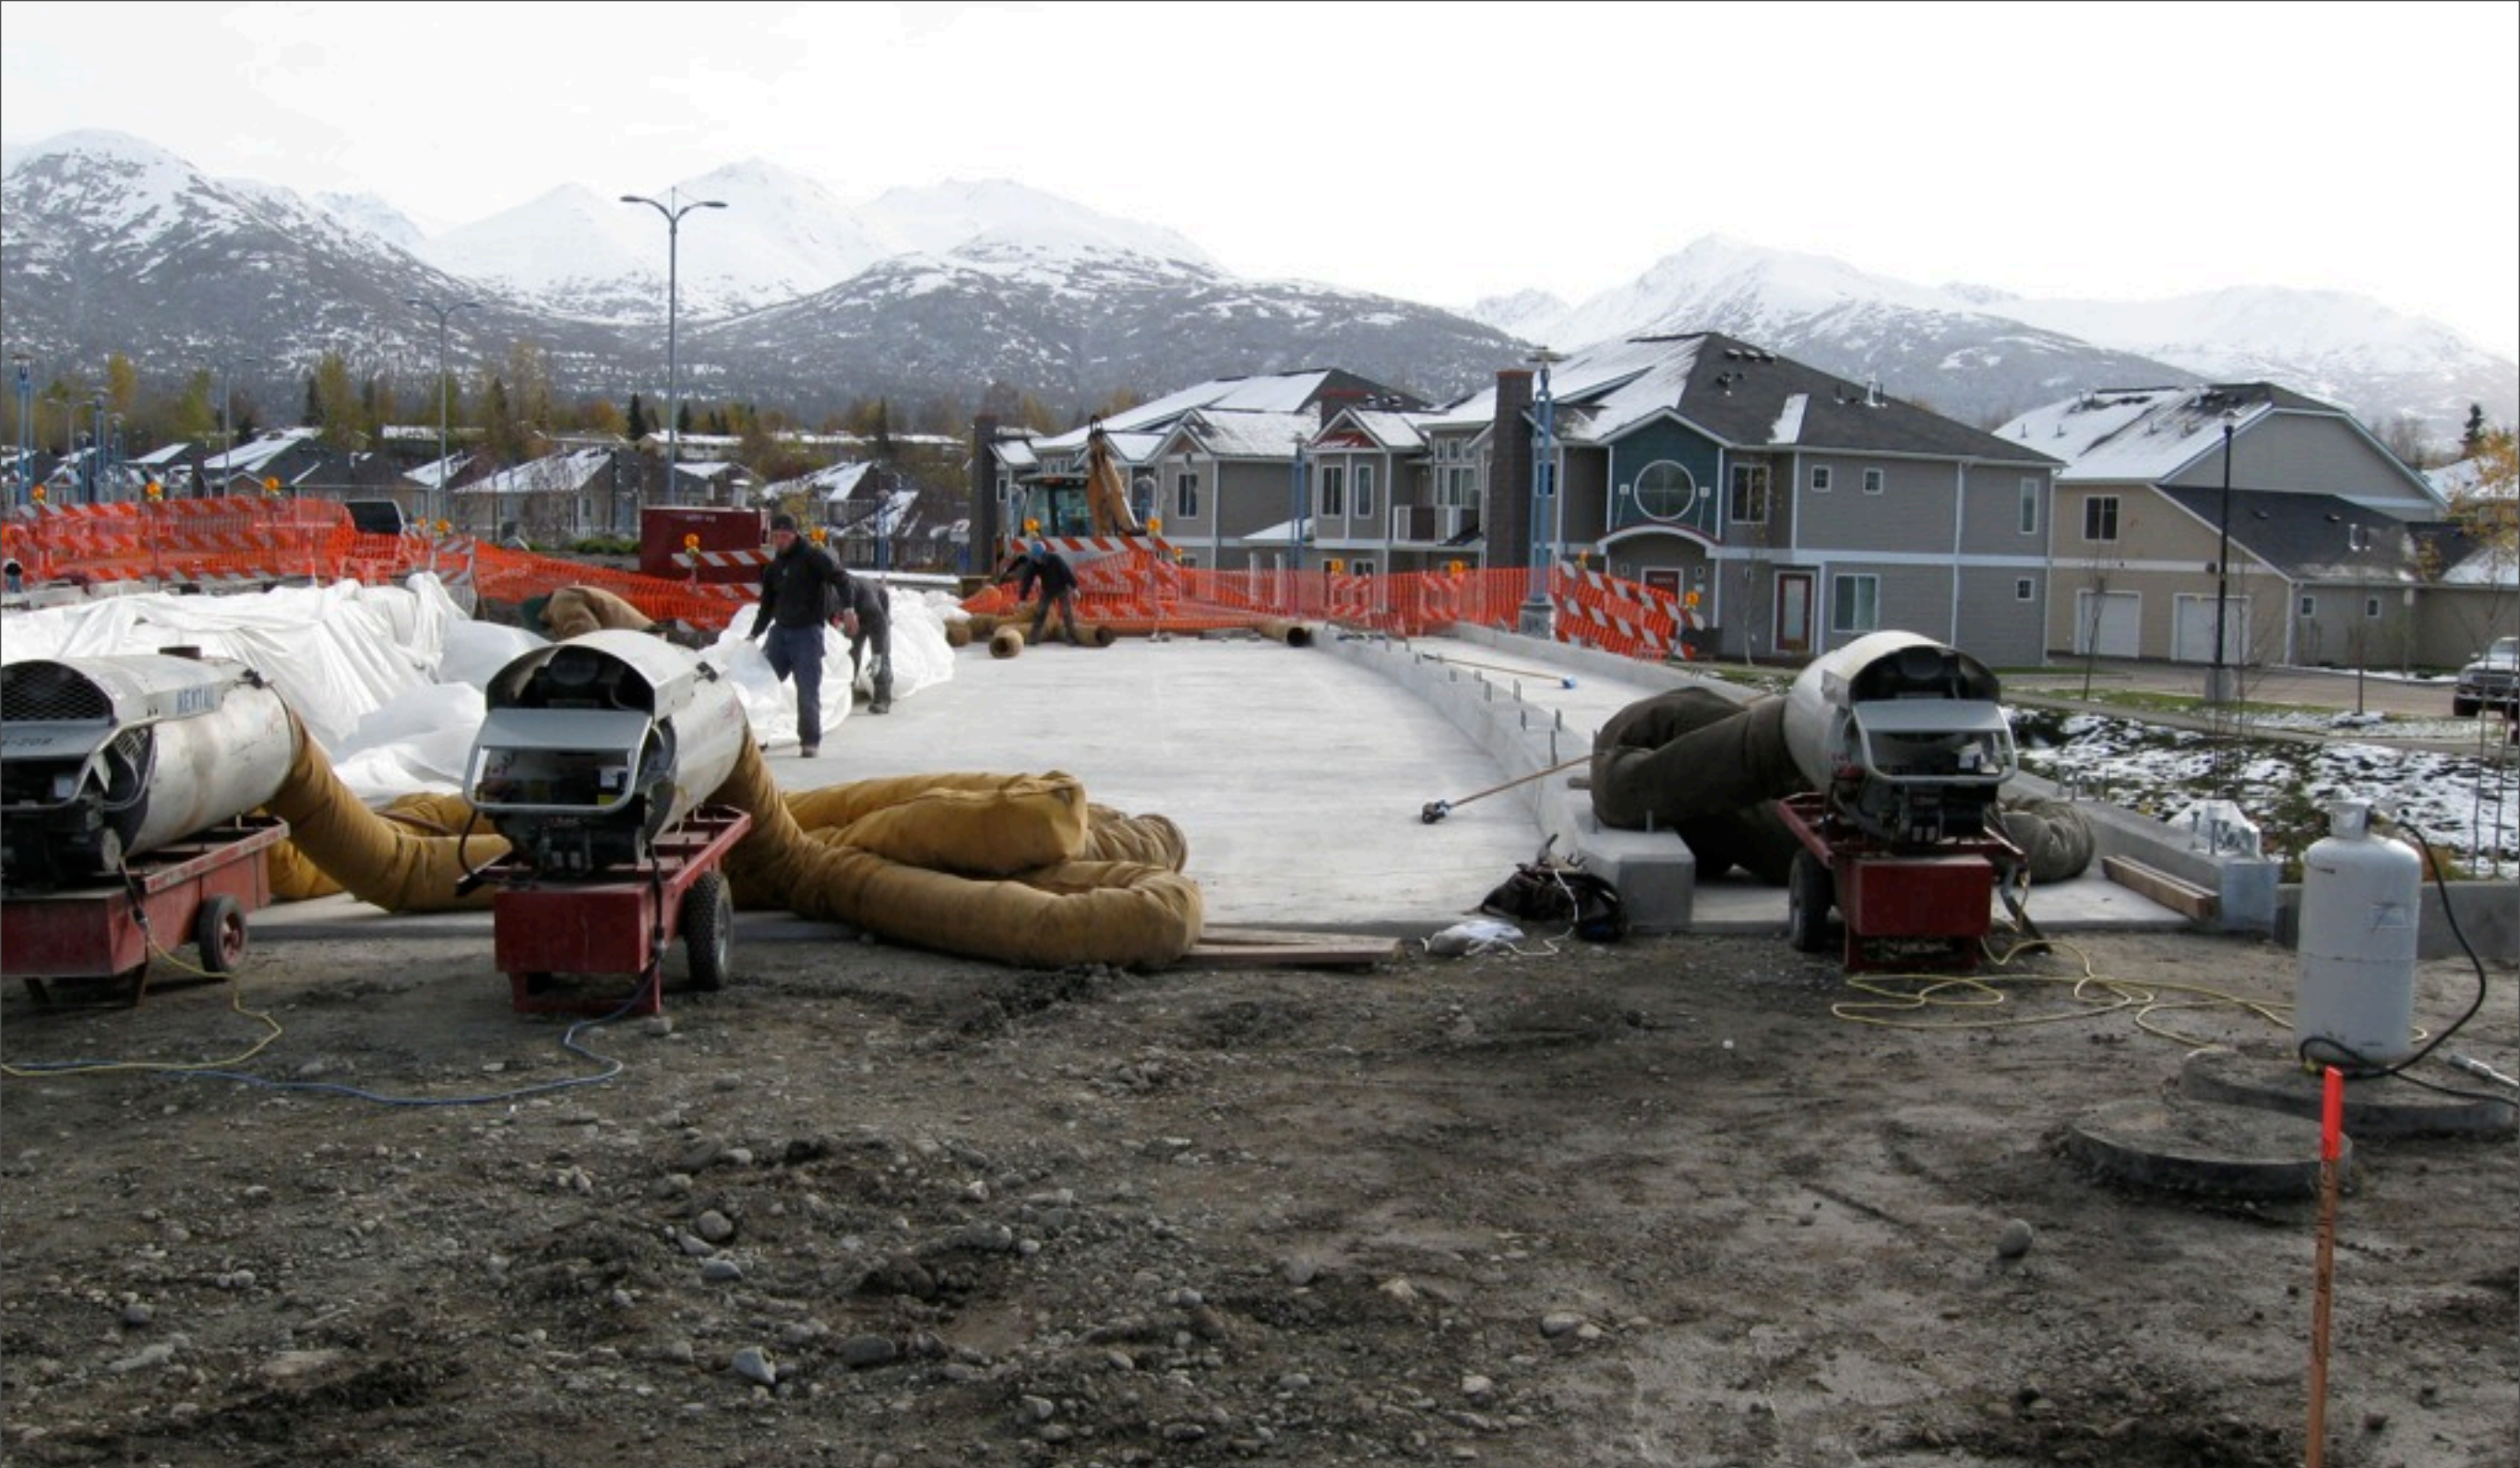
Heaters for warming up
the deck
